**AIRPHOTO INTERPRETATION OF SOILS  
OF STEUBEN COUNTY, INDIANA**

**APRIL, 1958  
No. 10**

**Joint  
Highway  
Research  
Project**

**P.T. Yeh**

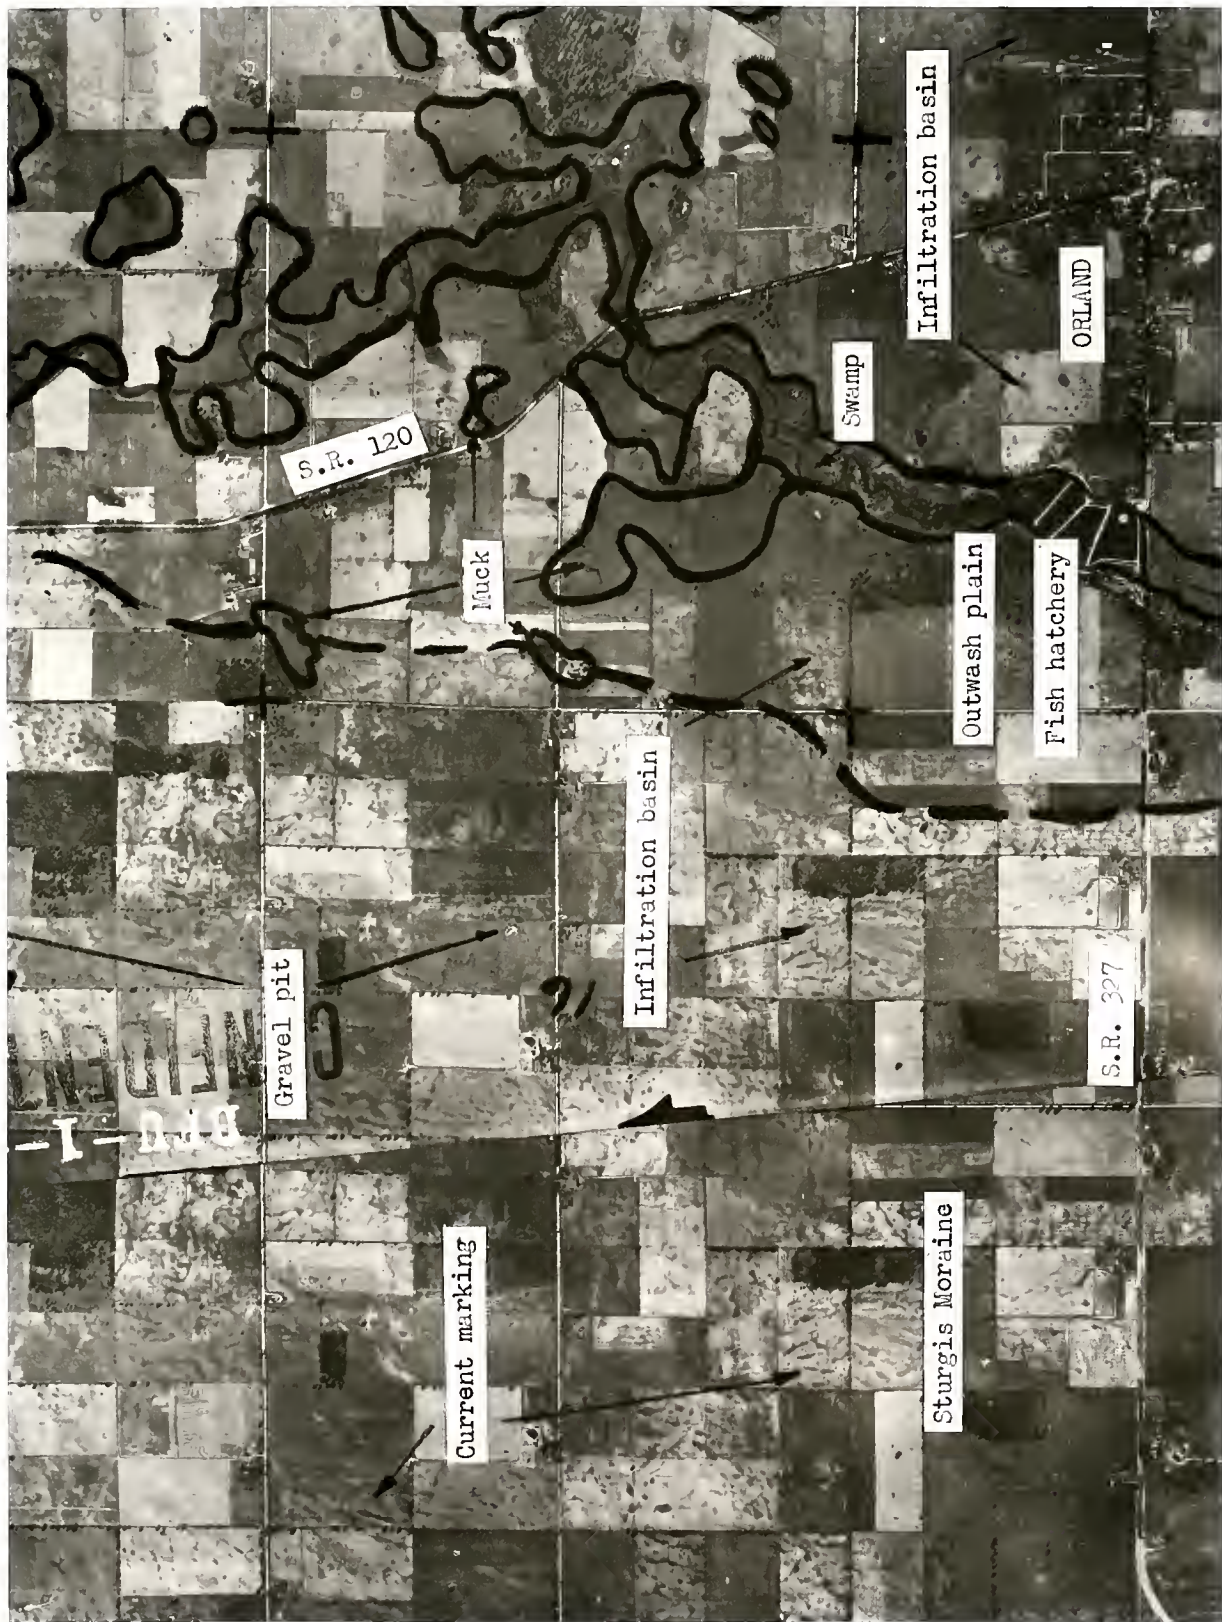
FIG. 5 AIRPHOTO PATTERN OF THE STURGIS MORaine.

Note the current markings on the moraine. The granular surface and subsurface soils contain numerous cobblestones.

Sturgis Moraine occupies only a small portion on the northwestern corner of Steuben County. The main ridge of the moraine lies between Sturgis and Burr Oak, Michigan, and runs southeasterly into Indiana, just north of Lexington and Orland, Indiana. This moraine has a width of 3 to 6 miles in St. Joseph County, Michigan, but is somewhat narrower and is more or less separable into a distinct ridge with intervening outwash plains in Indiana. The elevation of this moraine is about 1000 feet in the county and is about 50 feet above the adjacent outwash plains. Gently rolling topography, broken only by a few bouldery knolls and kettles, is revealed from the airphotos as shown in Figure 5. Numerous infiltration basins, some of them with a definite directional current marking, were registered on the airphotos. This photo pattern strongly indicates that the moraine had been subjected to a tremendous amount of water action. From the lack of surface drainage system and the number of infiltration basins, it is evident that the surface material is well drained and, consequently, is coarse-grained in texture. This is likely to be the result

The surface soils of this area are sandy in texture, mixed with a large amount of cobblestones. The subsoil between depths of 20 to 40 inches is medium to coarse sandy clay with gravel. The soils are identified as members of the Bellefontaine series. The typical soil profile is reproduced as Appendix A from Reference 16. The texture of these soils makes them ideal for subgrade and as a source of borrow.

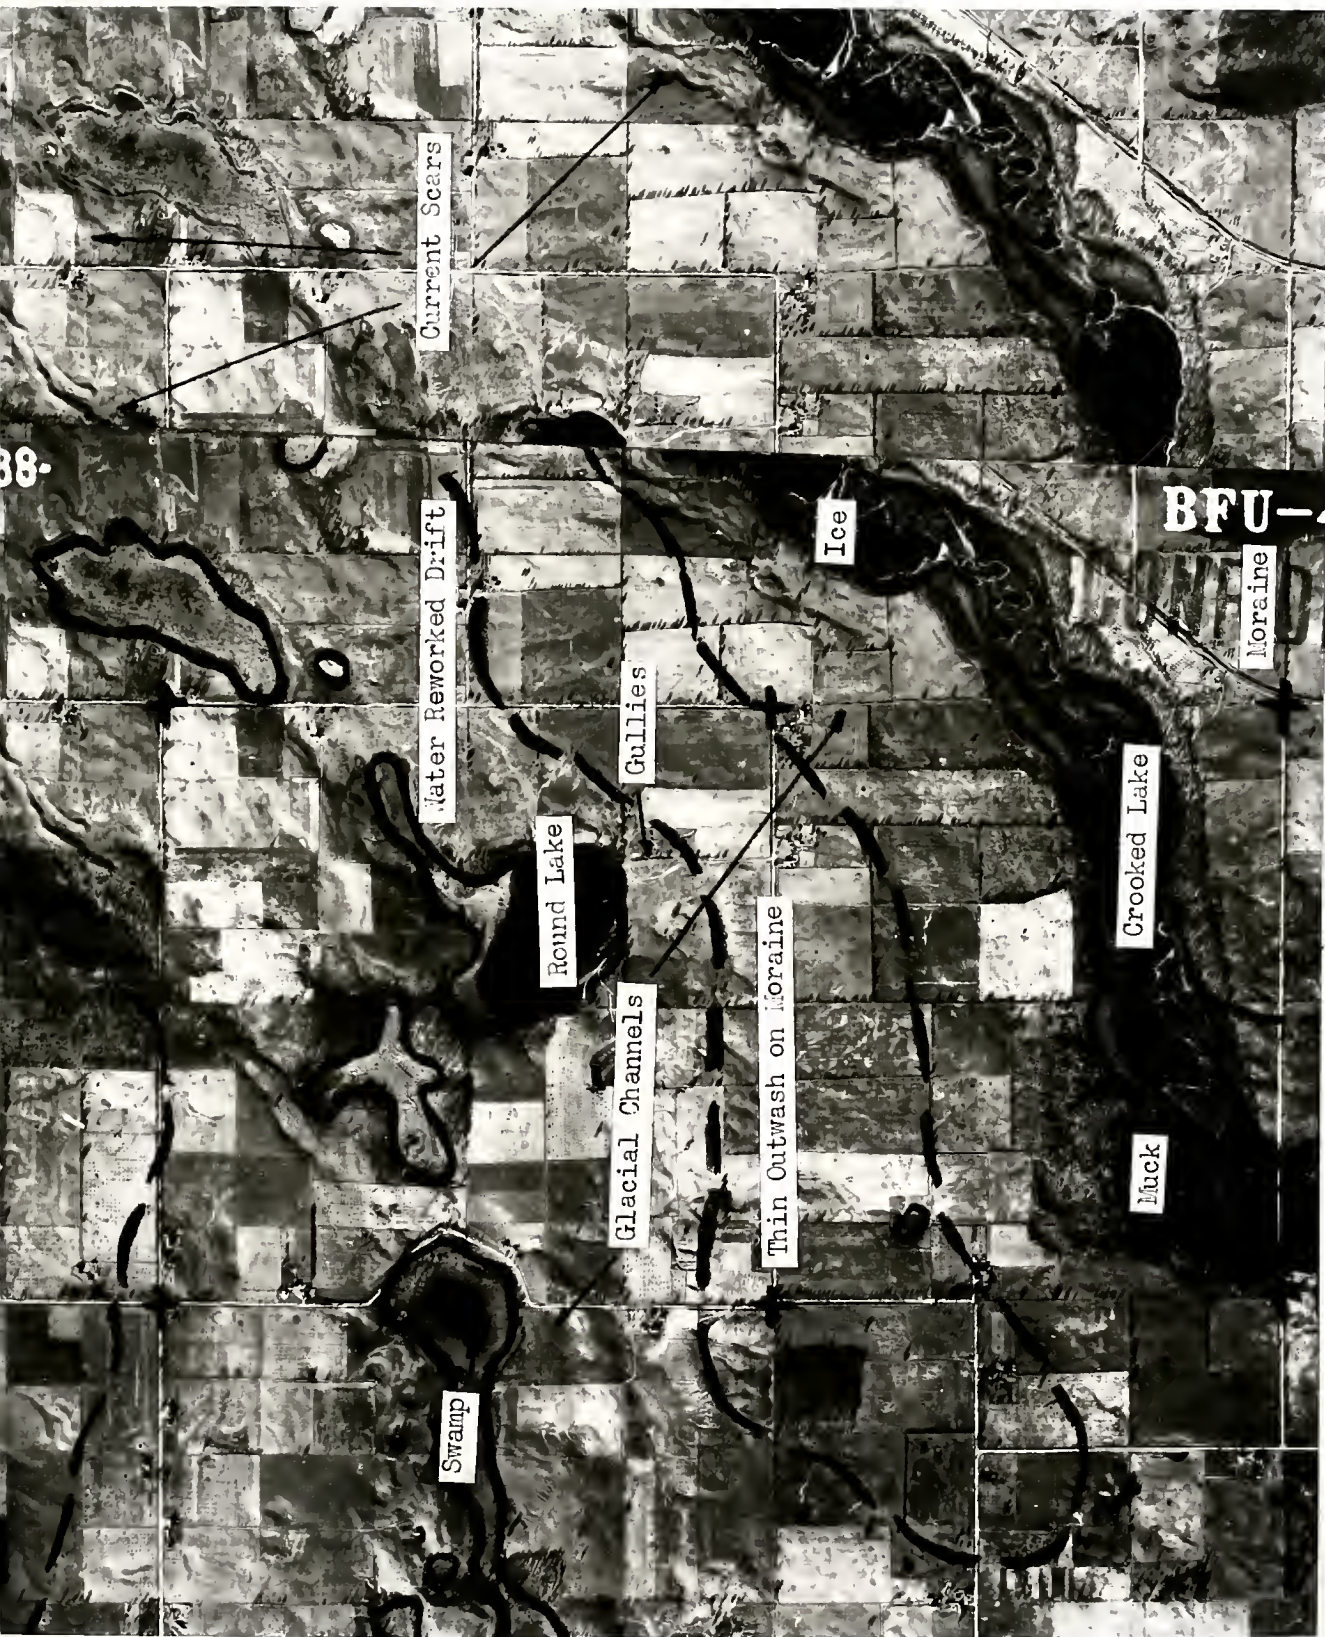
FIG. 6 STEREOGRAM OF THE UNIQUE GLACIAL CHANNEL.

Note the current markings in the channel. The sharp V-shaped gullies and the lack of surface drainage system indicate the granular nature of the deposit.

Along the bend of Pigeon Creek and the unique glacial channel west of Crooked Lake, a special pattern can be observed (See Figures 6, 12 and 13). The topography is more gentle than the moraine, yet much more rugged than the outwash plain and the adjoining thin outwash overlying moraines. Even though local relief in places is great (up to 70 feet), the ridges or domes are well rounded. Some of the ridges show graceful sweeping curves. This indicates that the area was subjected to a tremendous amount of water action during glacial recession. A channel was cut, and materials were reworked from the existing deposits. Since finer materials were eroded and carried away by the meltwater, sandy, gravelly and cobbly materials were left behind and redeposited according to the flow velocity.

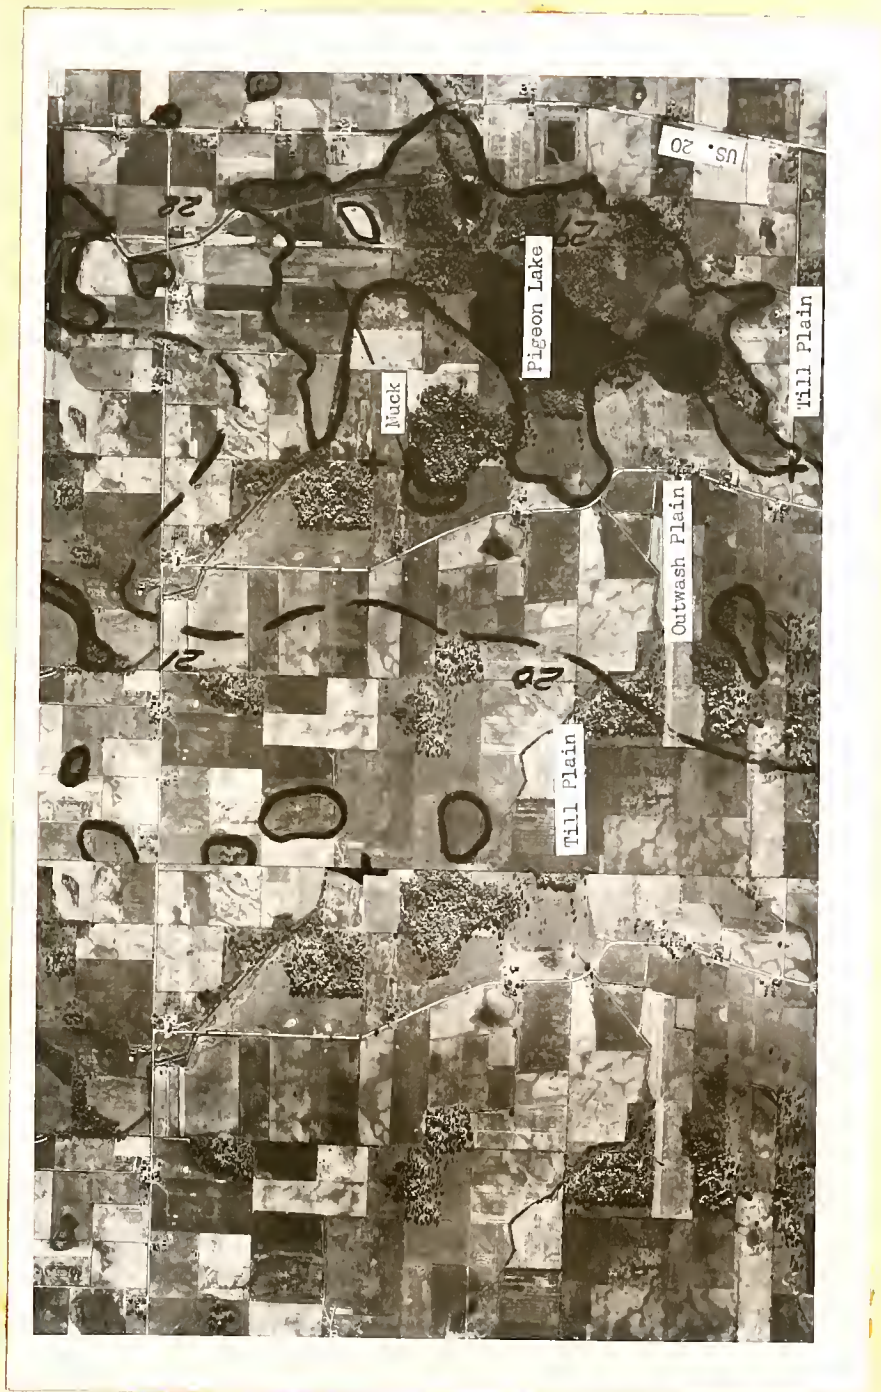
Figure 9. STEREOGRAM OF OUTWASH PLAIN LOCATED 3 MILES EAST OF ANGOLA

About three miles east of Angola, another outwash plain can be located (Figure 9). The plain, about two square miles in area, does not have as strong an outwash airphoto pattern as those mentioned previously; however, it is quite clear that the place is occupied by different material from the surrounding areas. The typical till plain drainage pattern shown on the adjoining till plain areas disappears. The surface becomes more smooth, and occasional infiltration basins are found. This indicated that the material is well drained internally; however, the material will be less granular in comparison with the other outwash plains, or the deposit may be thin in this area. It is reported from the Agricultural Soil Survey (4) that much of the area is underlain by a heavy stratum of clay, and the layer of calcareous gravel is less than 10 feet thick in many places and gradually thins out toward the north.

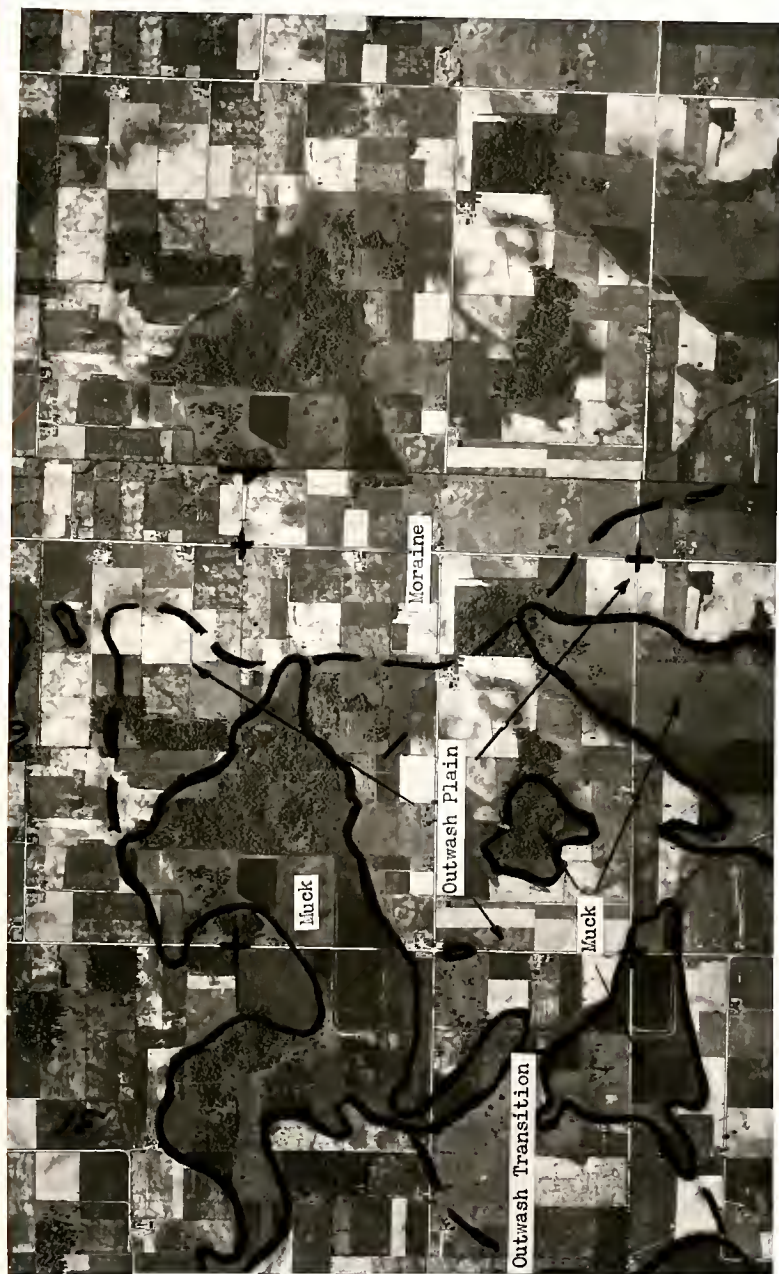
Figure 10. STEREOGRAM OF FINE-TEXTURED OUTWASH PLAIN LOCATED ABOUT 2 MILES SOUTH OF CLEAR LAKE

At the head water area of Pigeon Creek, about two miles south of Clear Lake, another outwash plain is found (Figure 10). This plain has a gentle slope, extended from the adjacent moraine on the southeast toward Pigeon Creek on the northwest. Although only a few infiltration basins can be found, the surface drainage pattern is different from the surrounding morainic areas. The topography becomes more gentle and flat. These factors indicate that the surface materials are more pervious than those of the moraine; however, the outwash deposit cannot be too thick. Otherwise, the influence of the underlying material will be absent from the airphoto. Judging from the nature of the surrounding moraine, the outwash deposit is a fine-textured material.

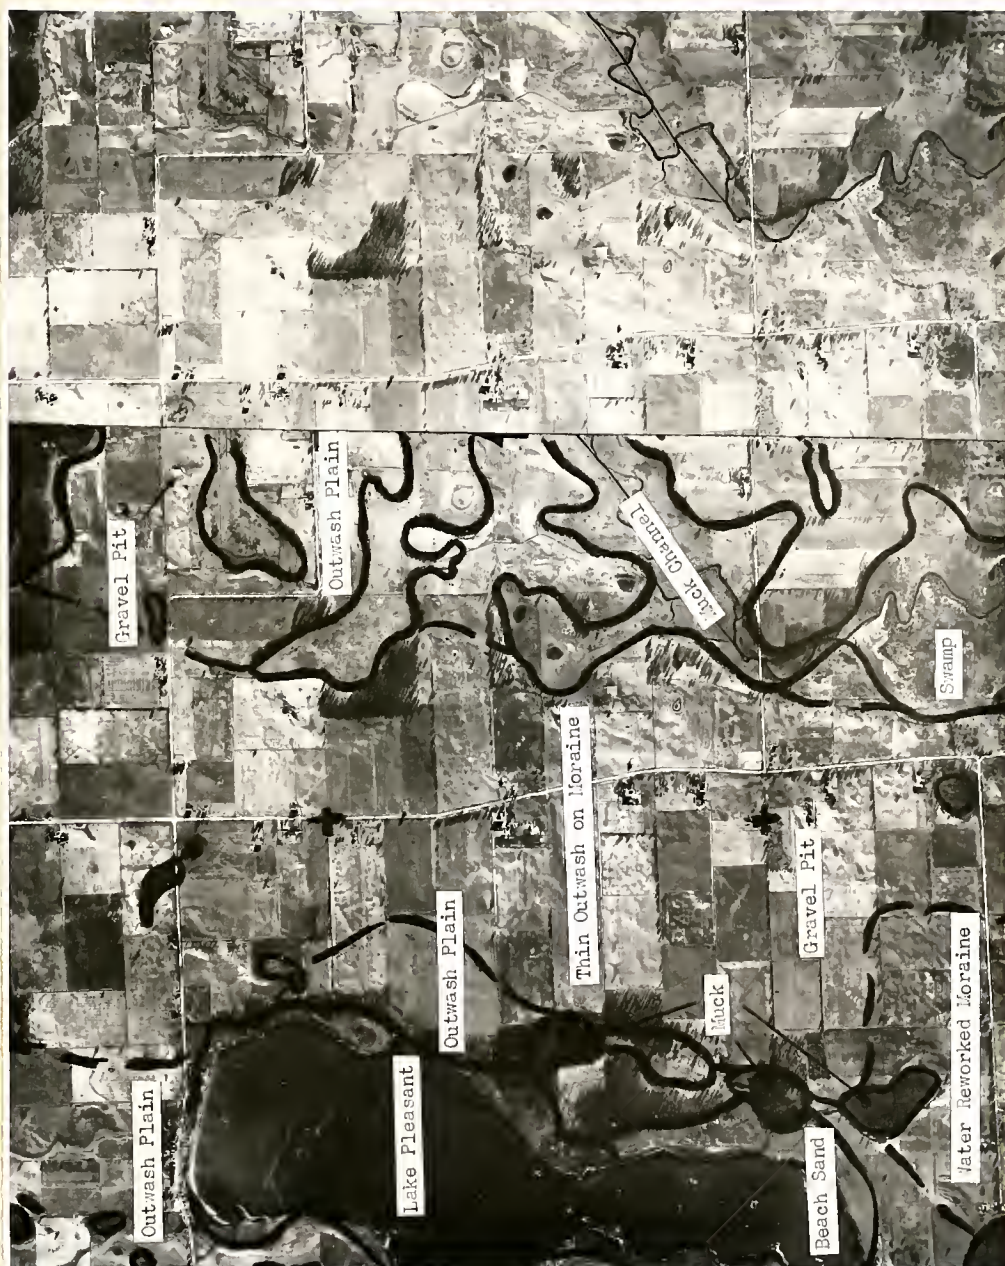
Figure 11. STEREOGRAM OF THIN OUTWASH ON MORAIN

Areas south of Lake Pleasant and in the vicinity of Lake George have a special airphoto pattern (Figure 11). The topography is generally flat with small local relief. Surface drainage, as well as infiltration basins, are absent from the surface. Topographically, these areas lie a little higher (about 10 to 20 feet) than the adjacent outwash plain. It is likely to be the case that during the glacial period, meltwater overflowed this area. The section has a fine sandy surface soil of about 10 inches. The subsoil is very friable, somewhat coarse-textured, sandy soil. The Agriculture Soil Survey reported that in most places the material in the subsurface layer has a slightly laminated structure and tends to break into friable fragments along horizontal planes when partly dry. The subsoil also contains a greater portion of silt and sand. Small round stones are strewn over the surface in many places. They are most numerous, as a rule, on slopes and small elevations; however, piles of stones may be found on level ground. The soil of this area can be classified in the Miami series.

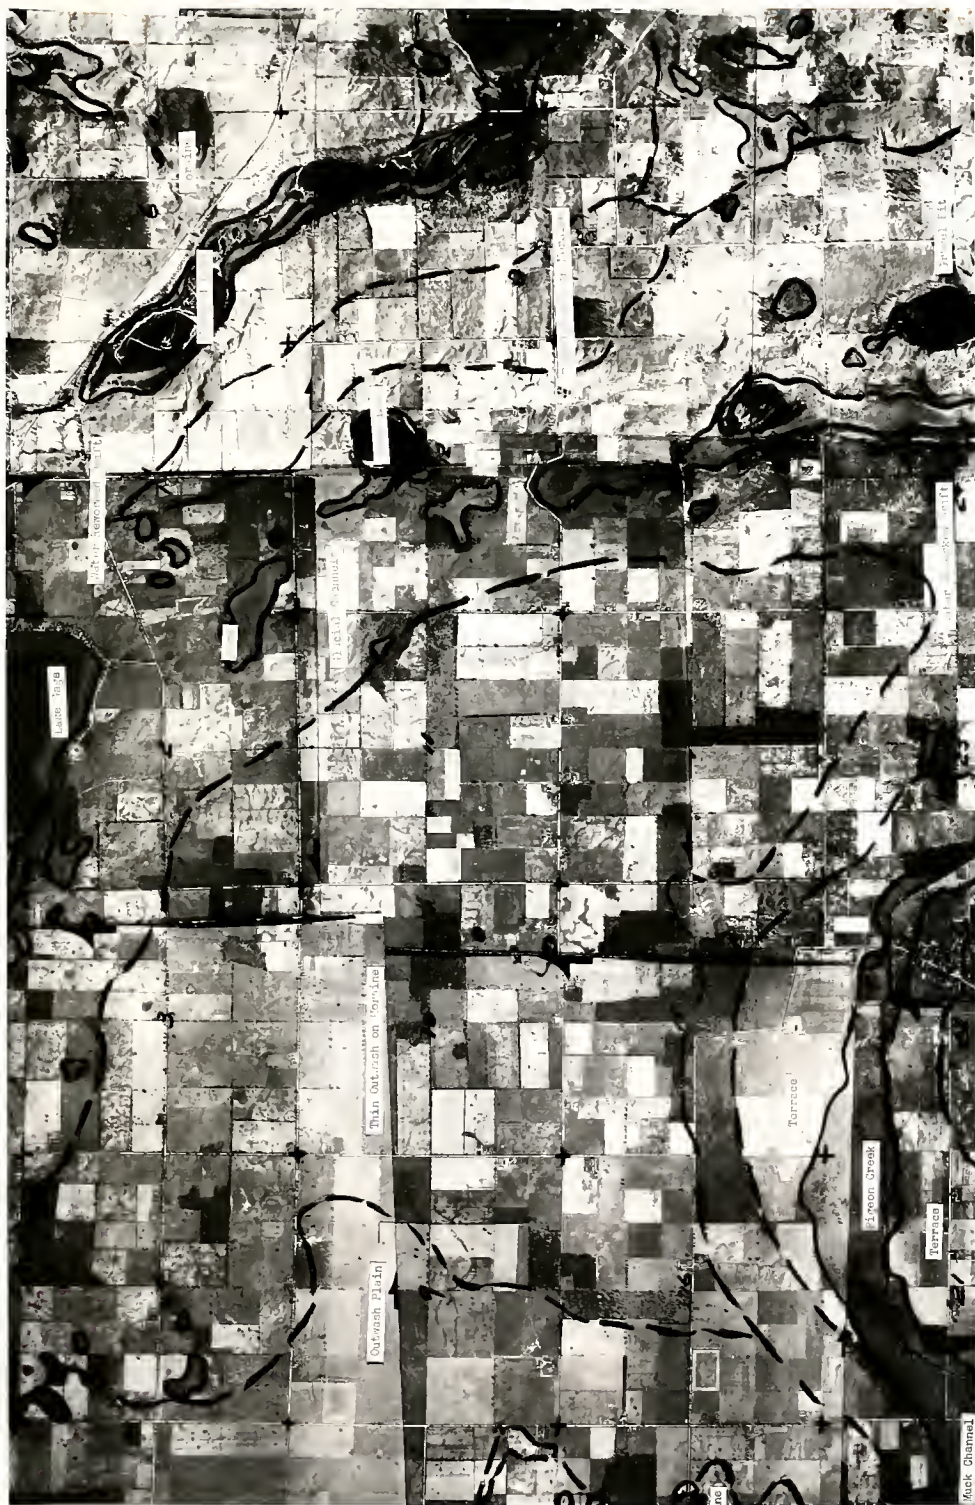
Figure 12. AERIAL PHOTO PATTERN OF THIN OUTWASH ON MORAINES  
Note the difference in photo pattern between moraine, thin  
outwash on moraine and the outwash plain.

North of Flint and south of Lake Gage there is an area of outwash deposits, overlying morainic deposits (Figure 12). It is separated into two parts by the glacial channel. It has an elevation of about 1050 feet,

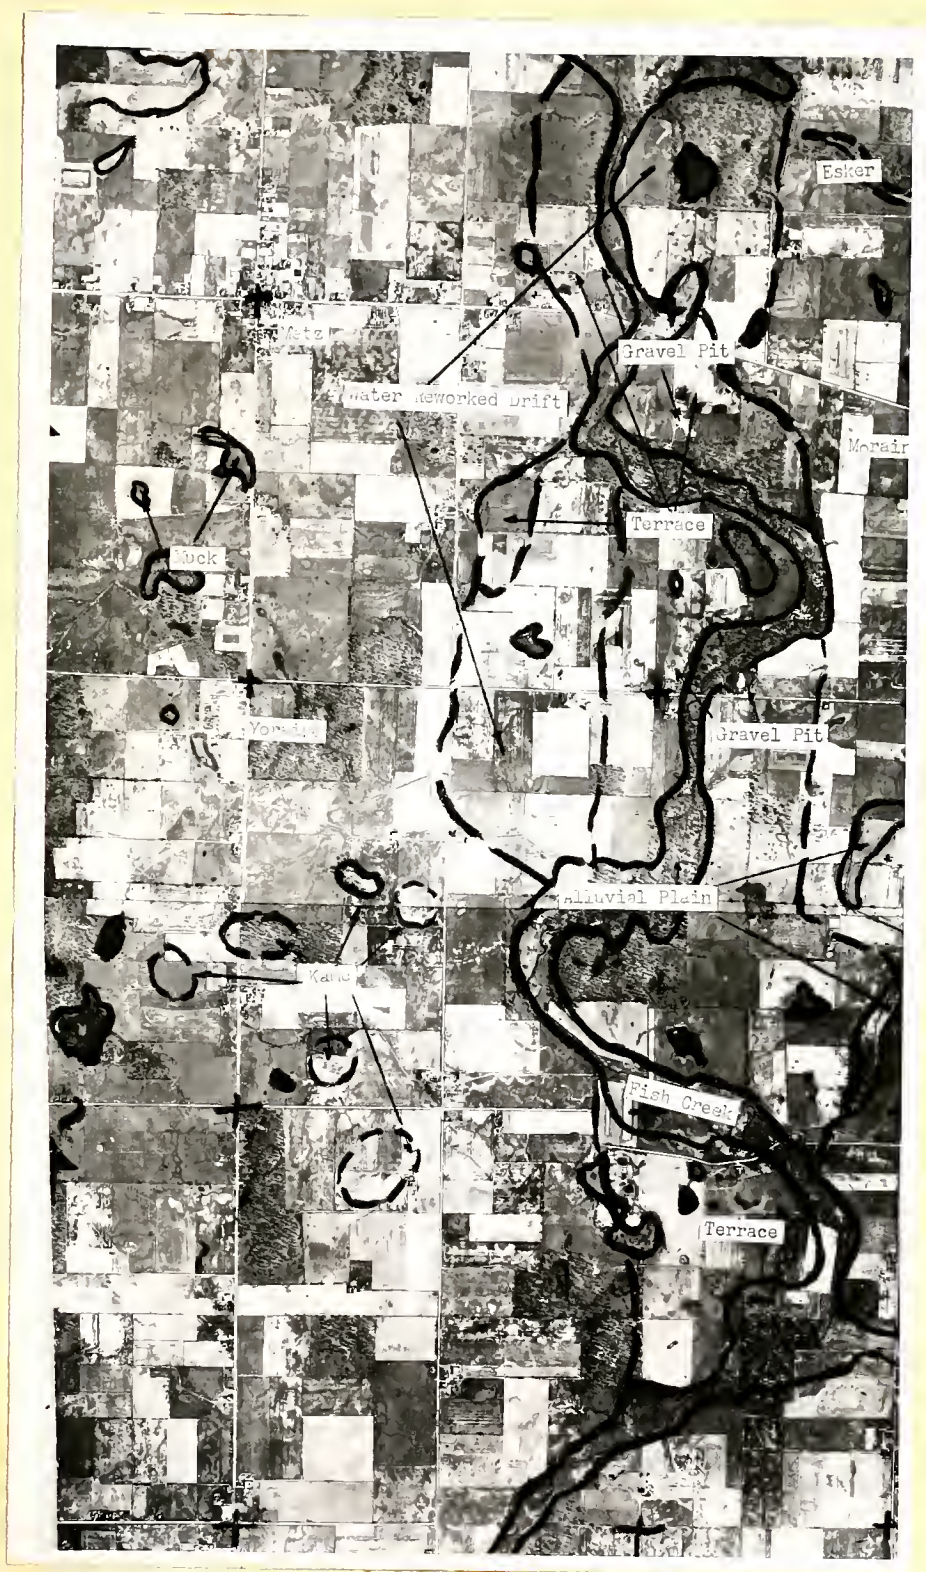
Figure 14. AIRPHOTO PATTERN OF TERRACE ALONG FISH CREEK

Another terrace (Figure 14) is located along Fish Creek near the eastern border of the county. The surface is much more rugged than the terrace on Pigeon Creek. No sharp break can be found between the terrace and the morainic upland; however, the topography of the terrace is much more subdued than the adjoining moraine. Surface drainage is generally absent. The rugged topography could be induced from the underlying material.

The only sizable alluvial plain in Steuben County is located along Fish Creek in the southeastern corner of the county (Figure 14). Most of the alluvial plain is subjected to occasional flooding. The composition of the alluvial soil is generally silt and sand with a variable amount of clay. It belongs to the Griffin series.

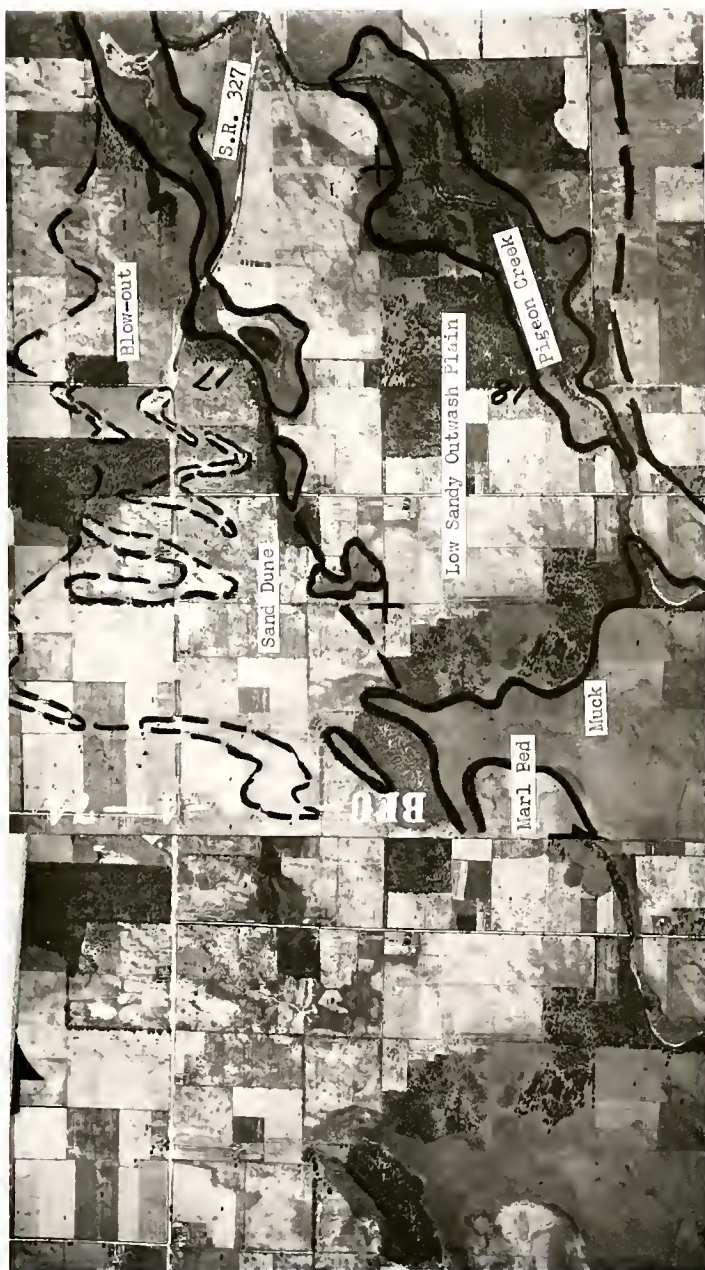
Figure 15. STEREOGRAM OF SAND DUNE FORMATION ON OUTWASH PLAIN.  
 The low outwash plain is about 50 feet below the sand dune area.  
 A number of blow-outs can be seen clearly from the photo.

Large dune formations can be observed on the airphoto north of Pigeon Creek along State Highway 327 near the western border (Figure 15). Blow-out areas on the sand dune can be seen. The sand seems to be blown up from the low sandy outwash plain which lies about 50 feet below and on the west of the sand dune area.

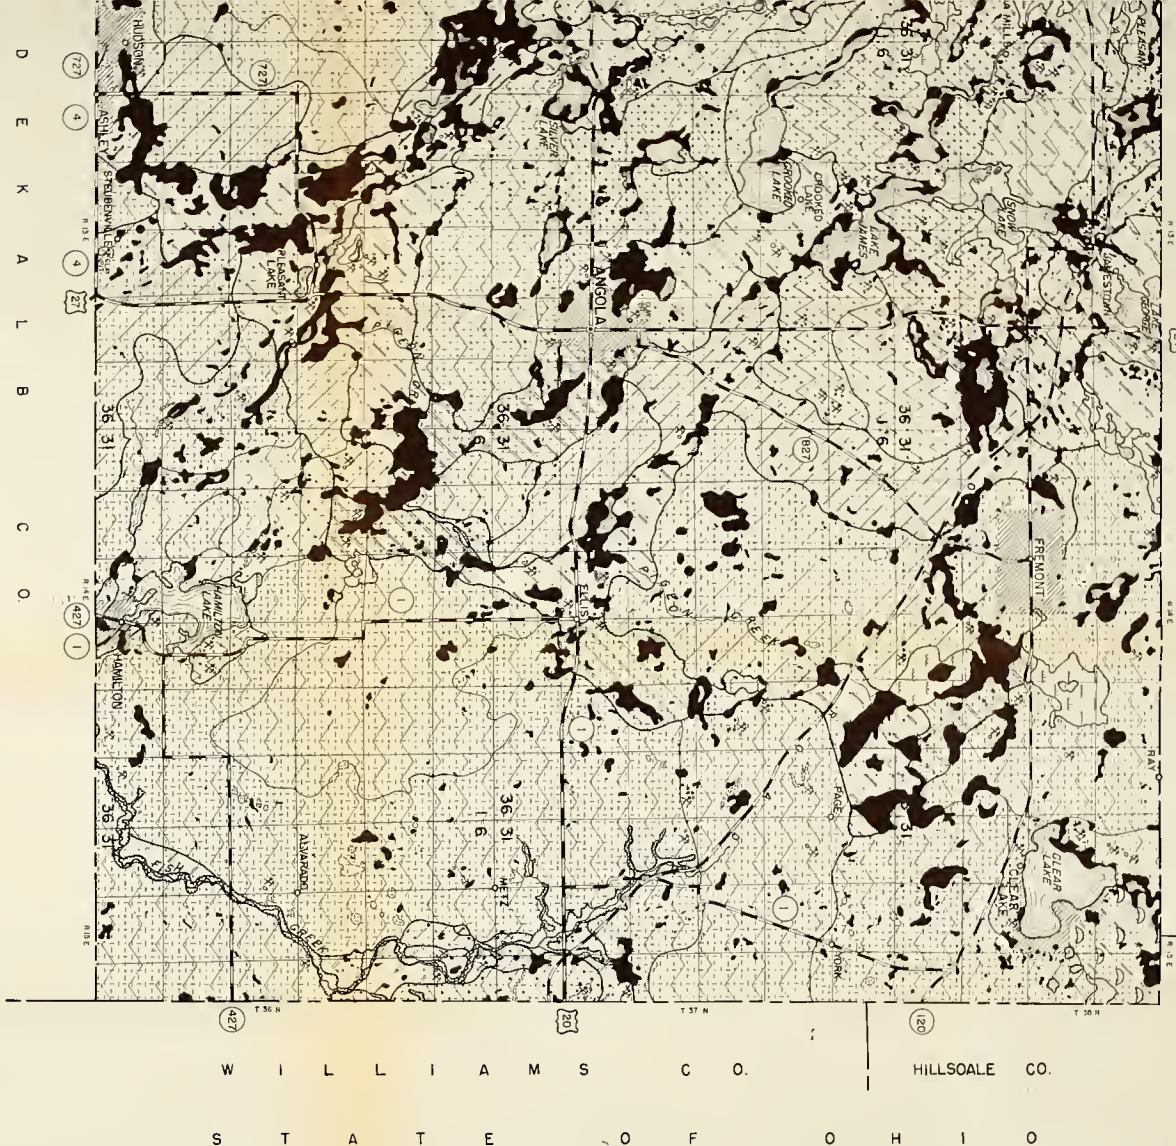
ENGINEERING SOILS MAP  
STEUBEN COUNTY  
INDIANA

PREPARED FROM  
1938 AAA AERIAL PHOTOGRAPHS
